REPORT OF
ENVIRONMENTAL SITE ASSESSMENT-PHASE I

VACANT LAND
3346 WILLIAM AVENUE
MIAMI, FLORIDA 33133

AUG 2013
13 ESA 179

USSE Project Number: **13-ESA 179**

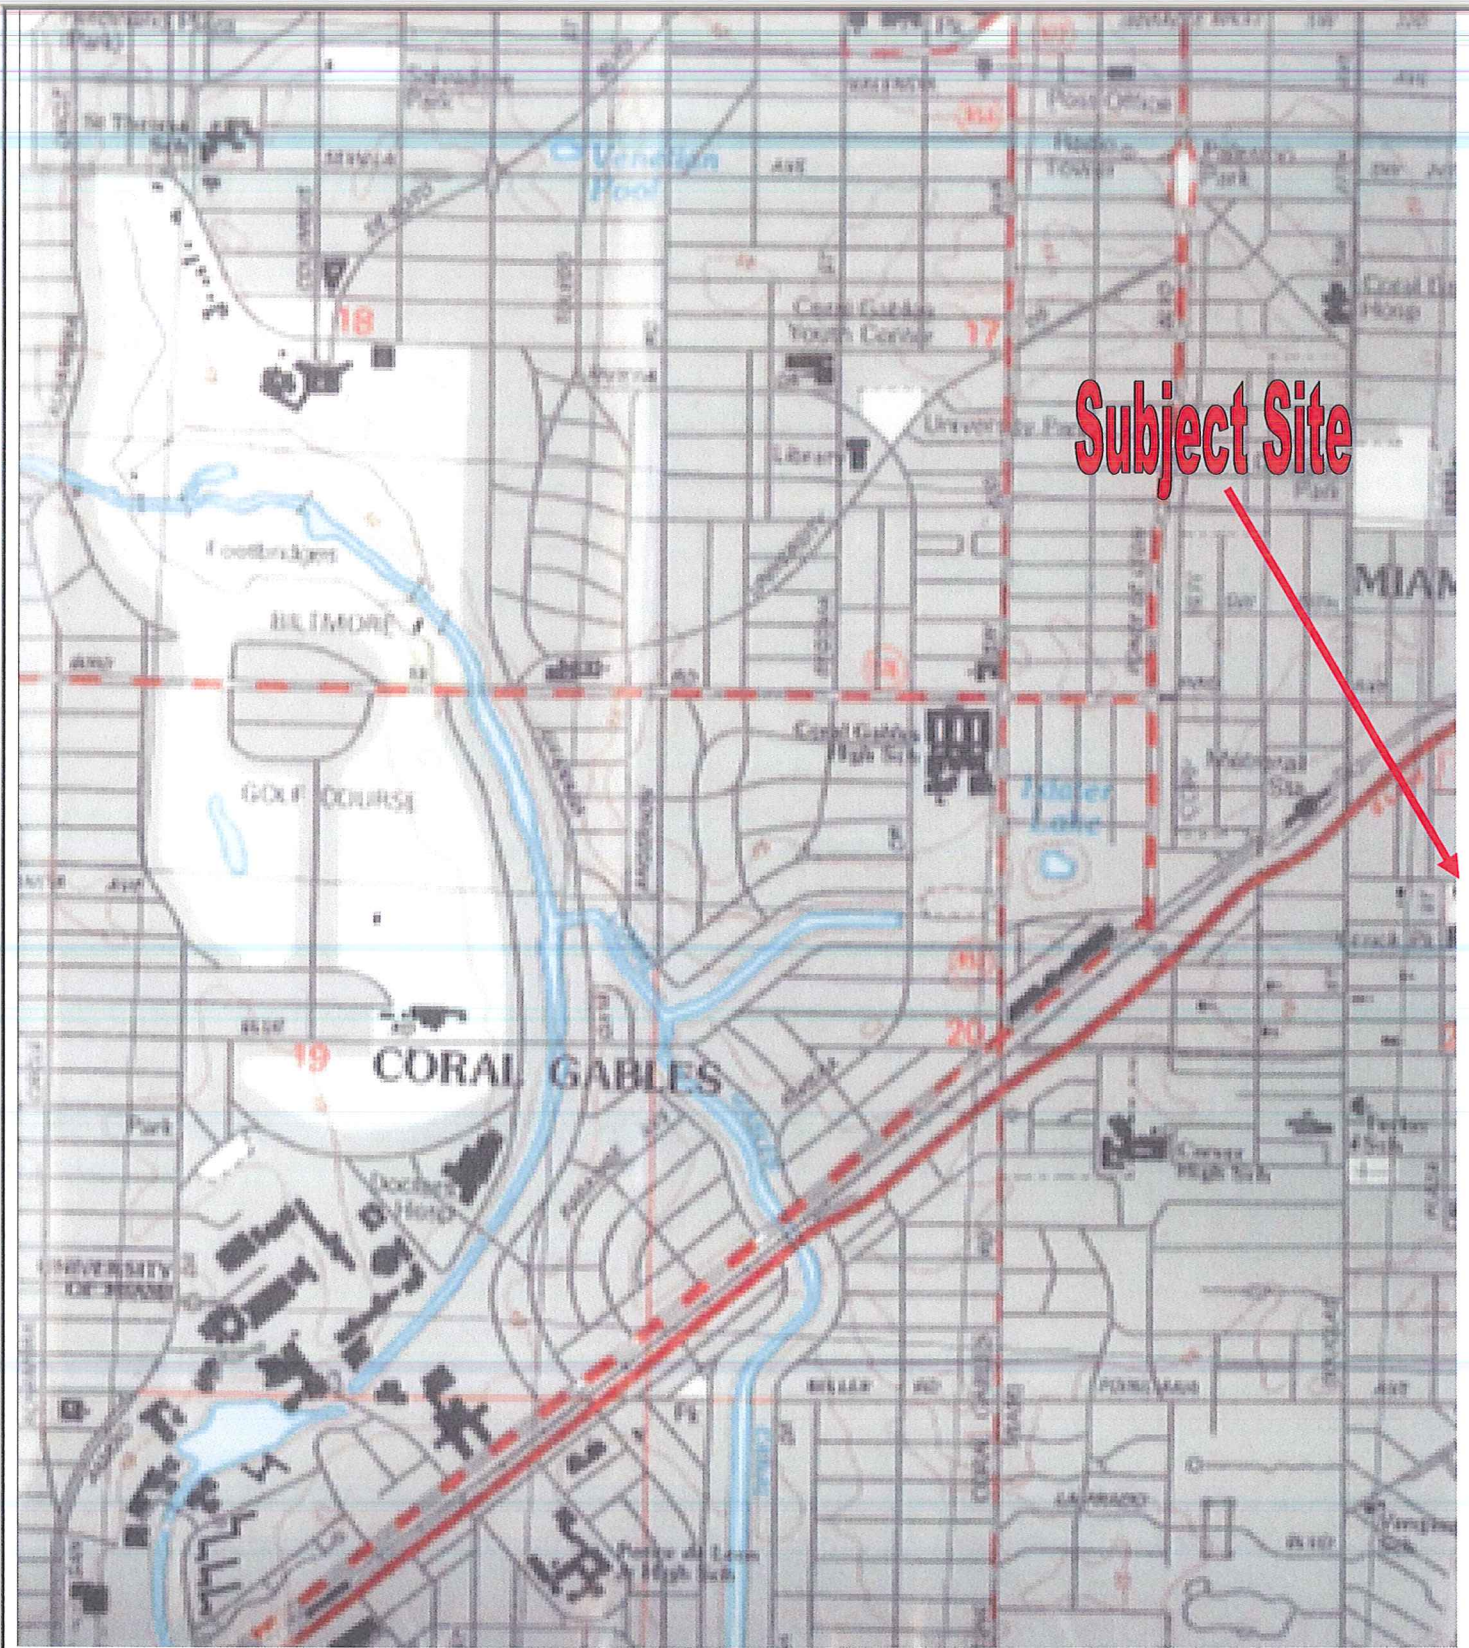
**US GEOLOGICAL SURVEY
 MAP
 (FIGURE 1)
 USSE PROJECT NO.:
 13 ESA 179**

Based on a published geological map for South Miami, FL Quadrangle (1994), William Avenue shows as unimproved road. Refer to Figure 1 in Appendix A for a copy of the applicable portion of the South Miami, FL quadrangle.

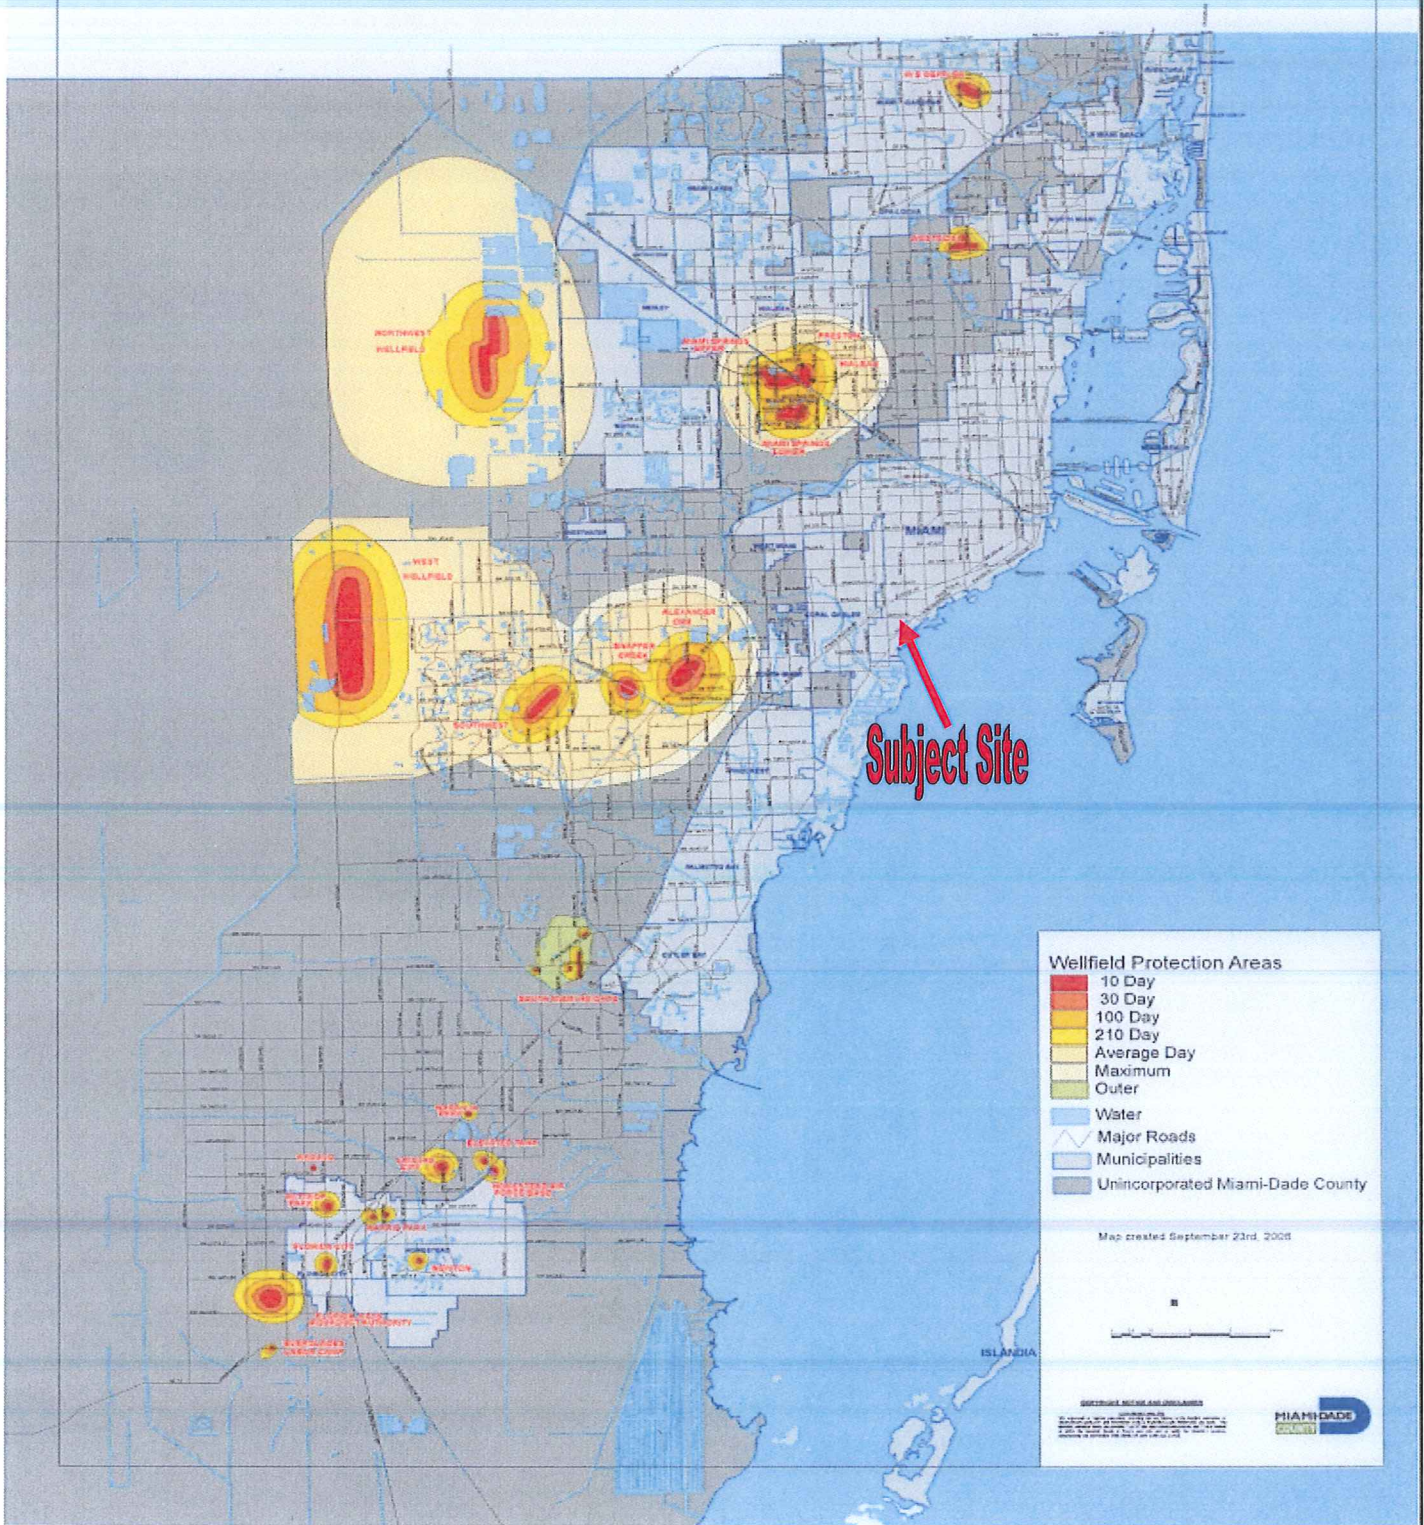
WELLFIELD PROTECTION
 AREA MAP (FIGURE 4)
 USSE PROJECT NO.:
 13 ESA 179

According to the Miami-Dade County Well field Protection Map, the subject property is not located on Wellfield protection area. Refer to figures 3 and 4 Appendix A for a copy of the applicable portion of the Miami-Dade County Solid Waste Disposal Sites map and Well-Field Protection Area map, where the subject site is marked in red on both.

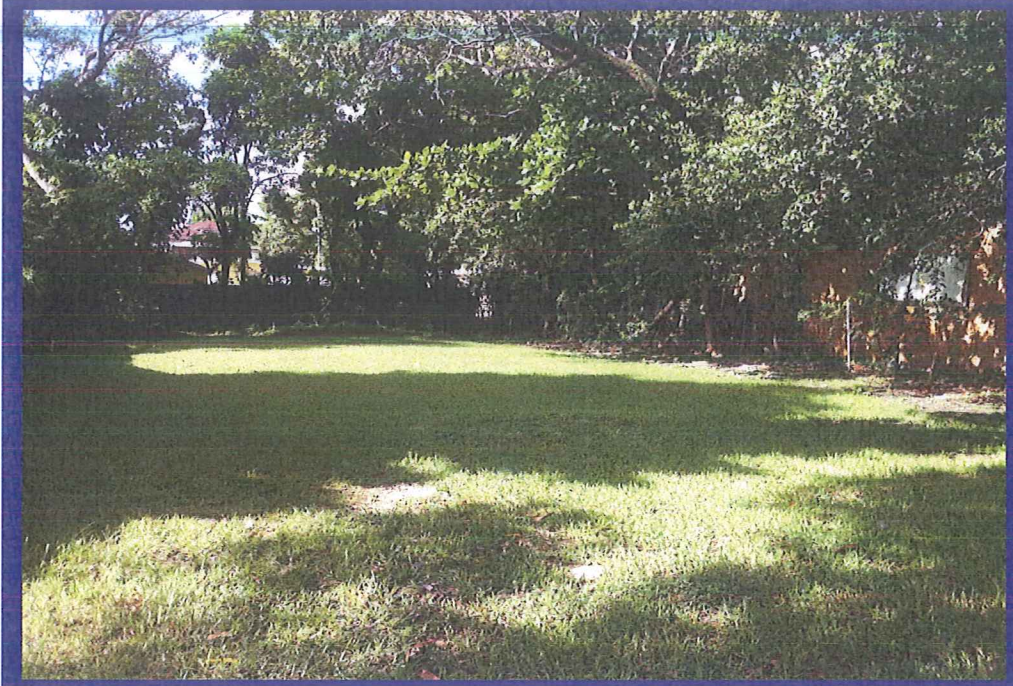
1:
Subject site

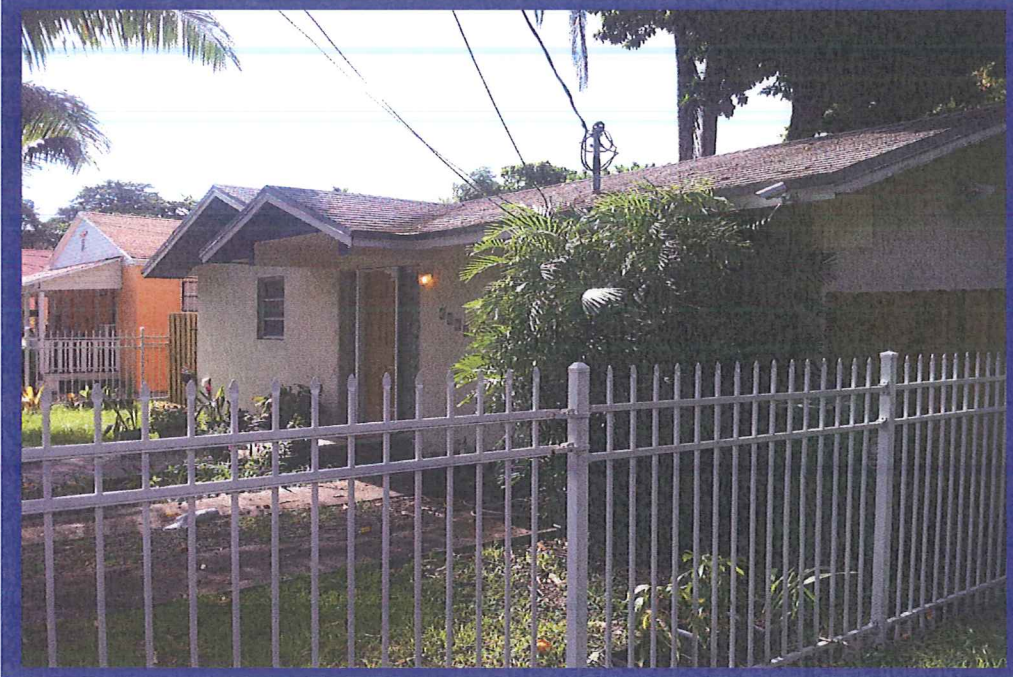
2:
East neighboring
site

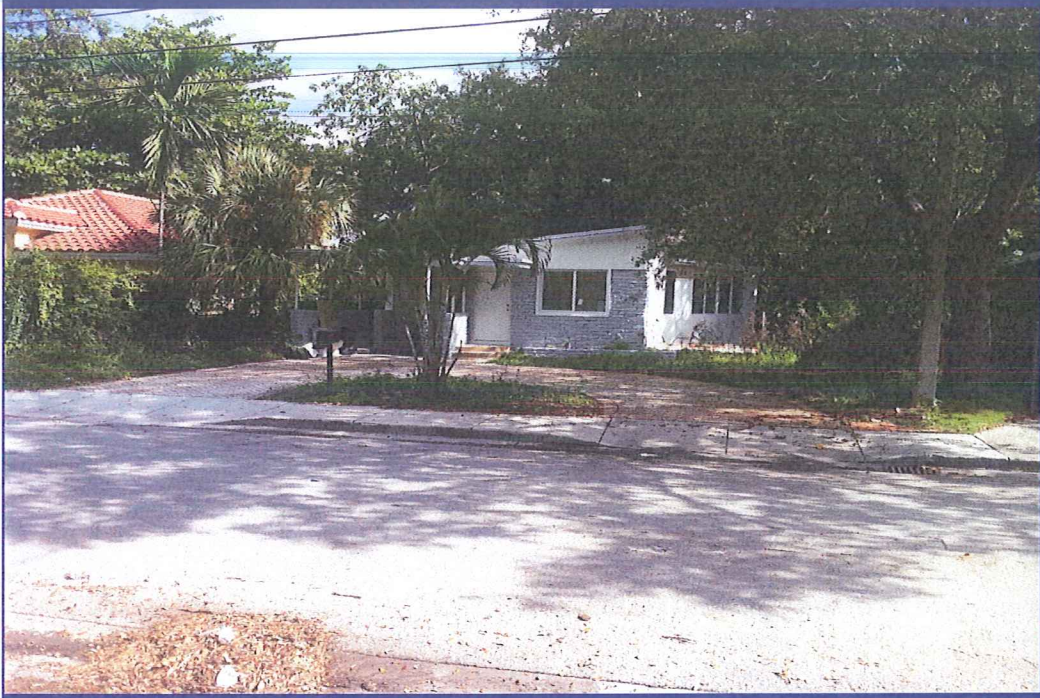
3:
North
neighboring
property

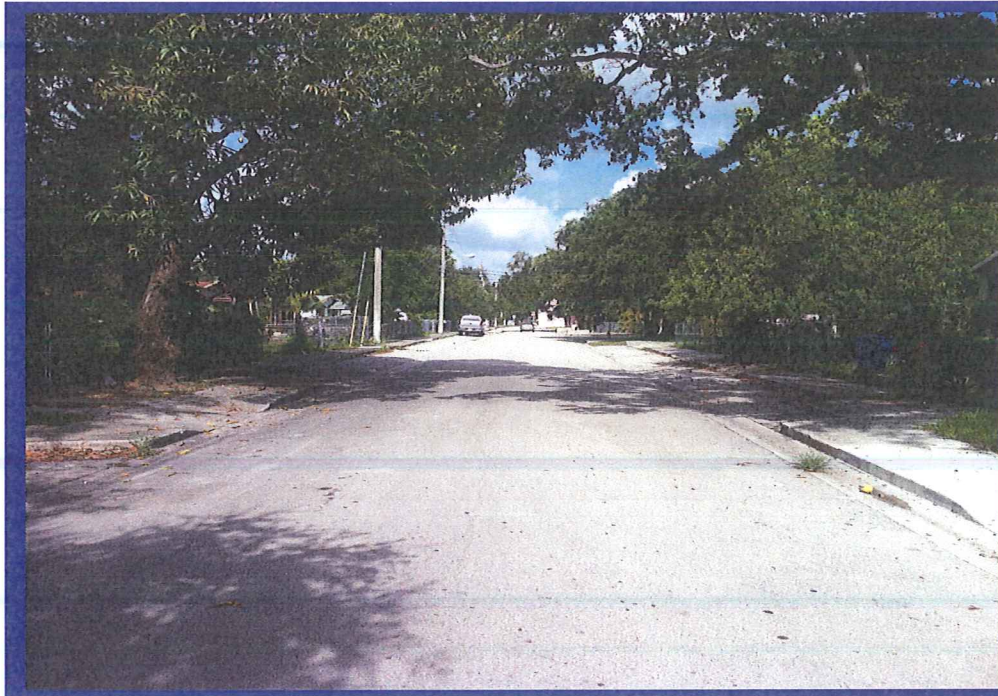
4:
Viewing east
along William
Avenue near the
subject site
