REPORT OF
ENVIRONMENTAL SITE ASSESSMENT-PHASE I

VACANT LAND
3346 WILLIAM AVENUE
MIAMI, FLORIDA 33133

AUG 2013
13 ESA 179

USSE Project Number: **13-ESA 179**

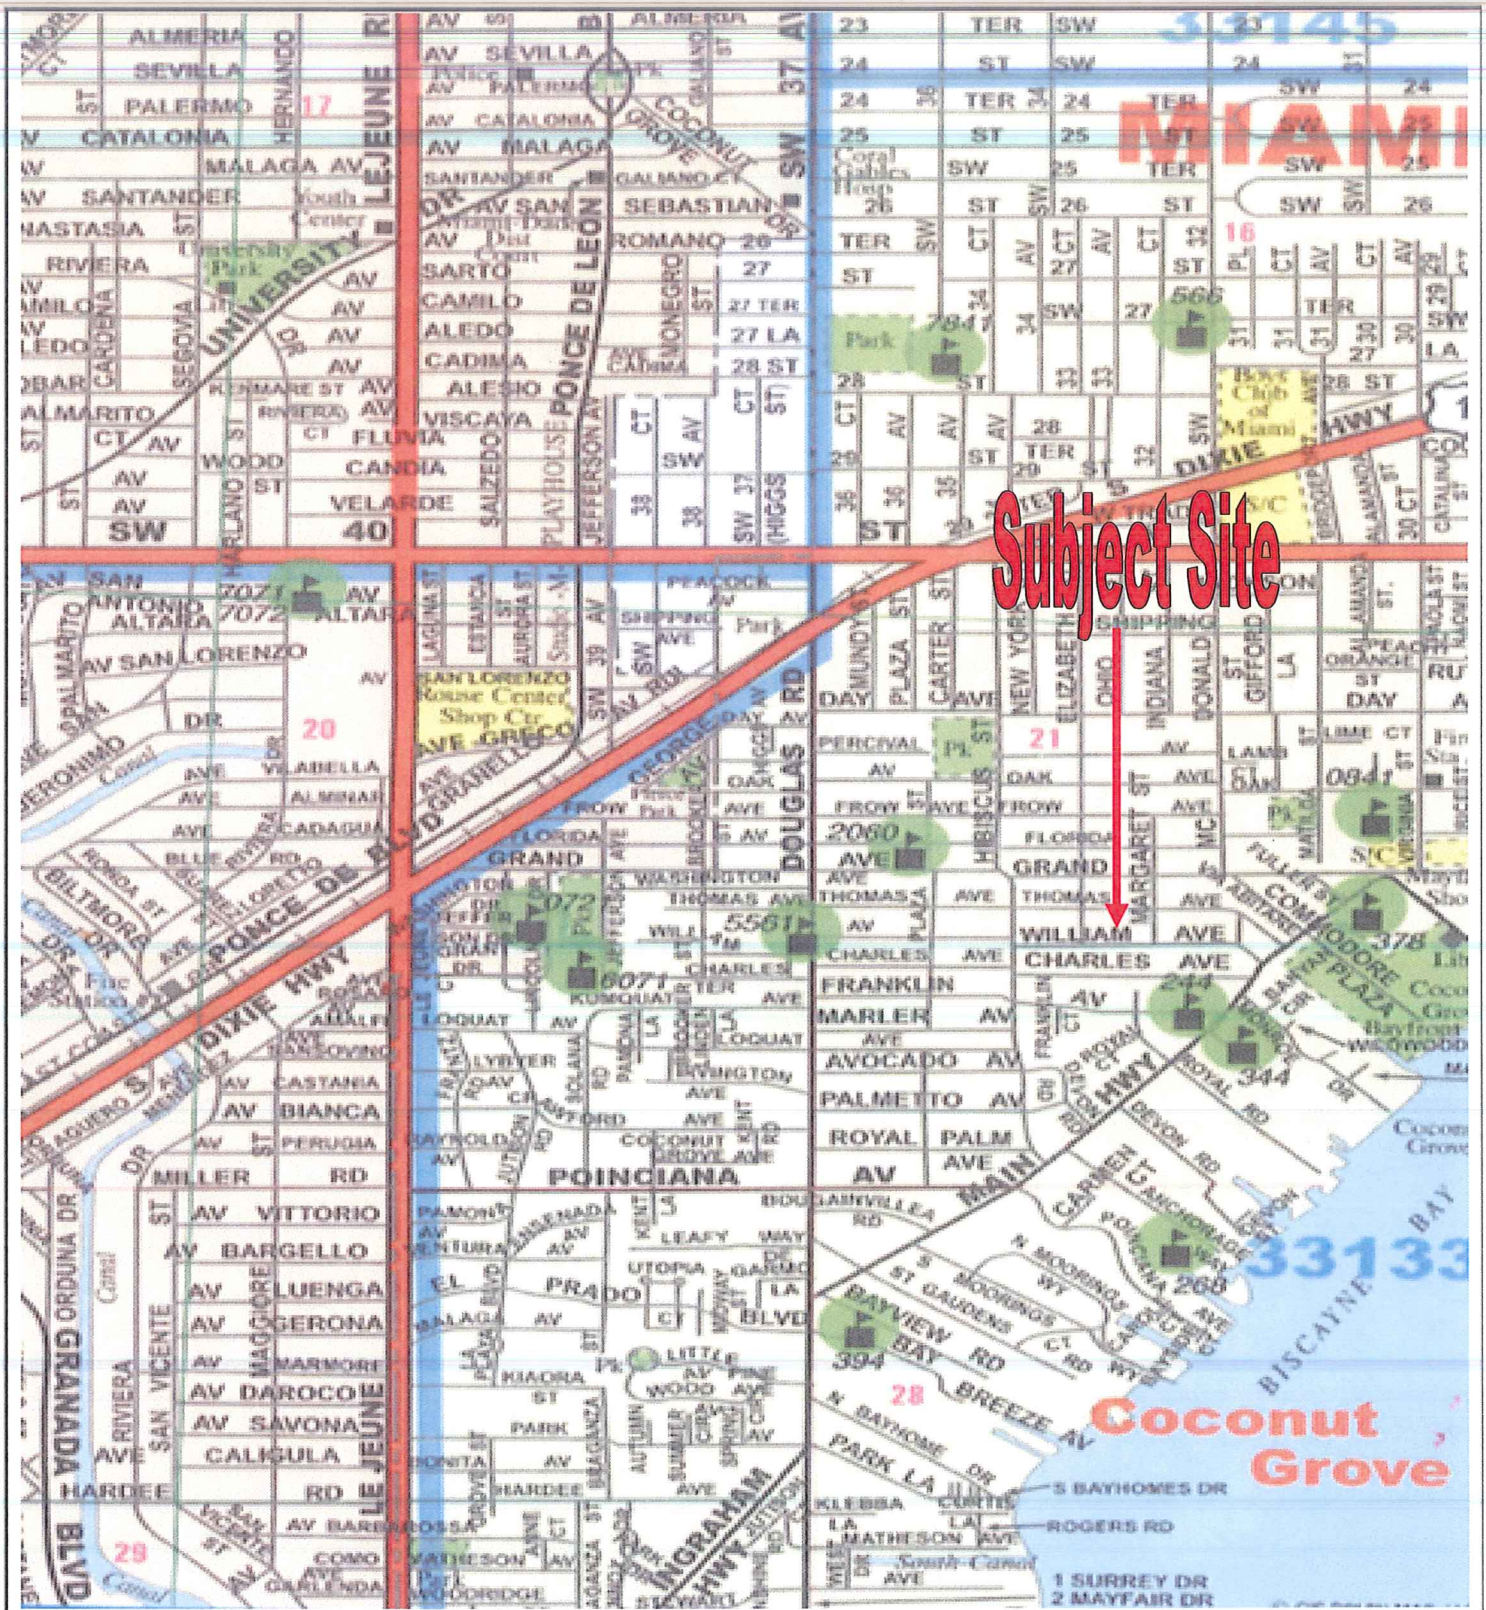
**US GEOLOGICAL SURVEY
 MAP
 (FIGURE 1)
 USSE PROJECT NO.:
 13 ESA 179**

Based on a published geological map for South Miami, FL Quadrangle (1994), William Avenue shows as unimproved road. Refer to Figure 1 in Appendix A for a copy of the applicable portion of the South Miami, FL quadrangle.

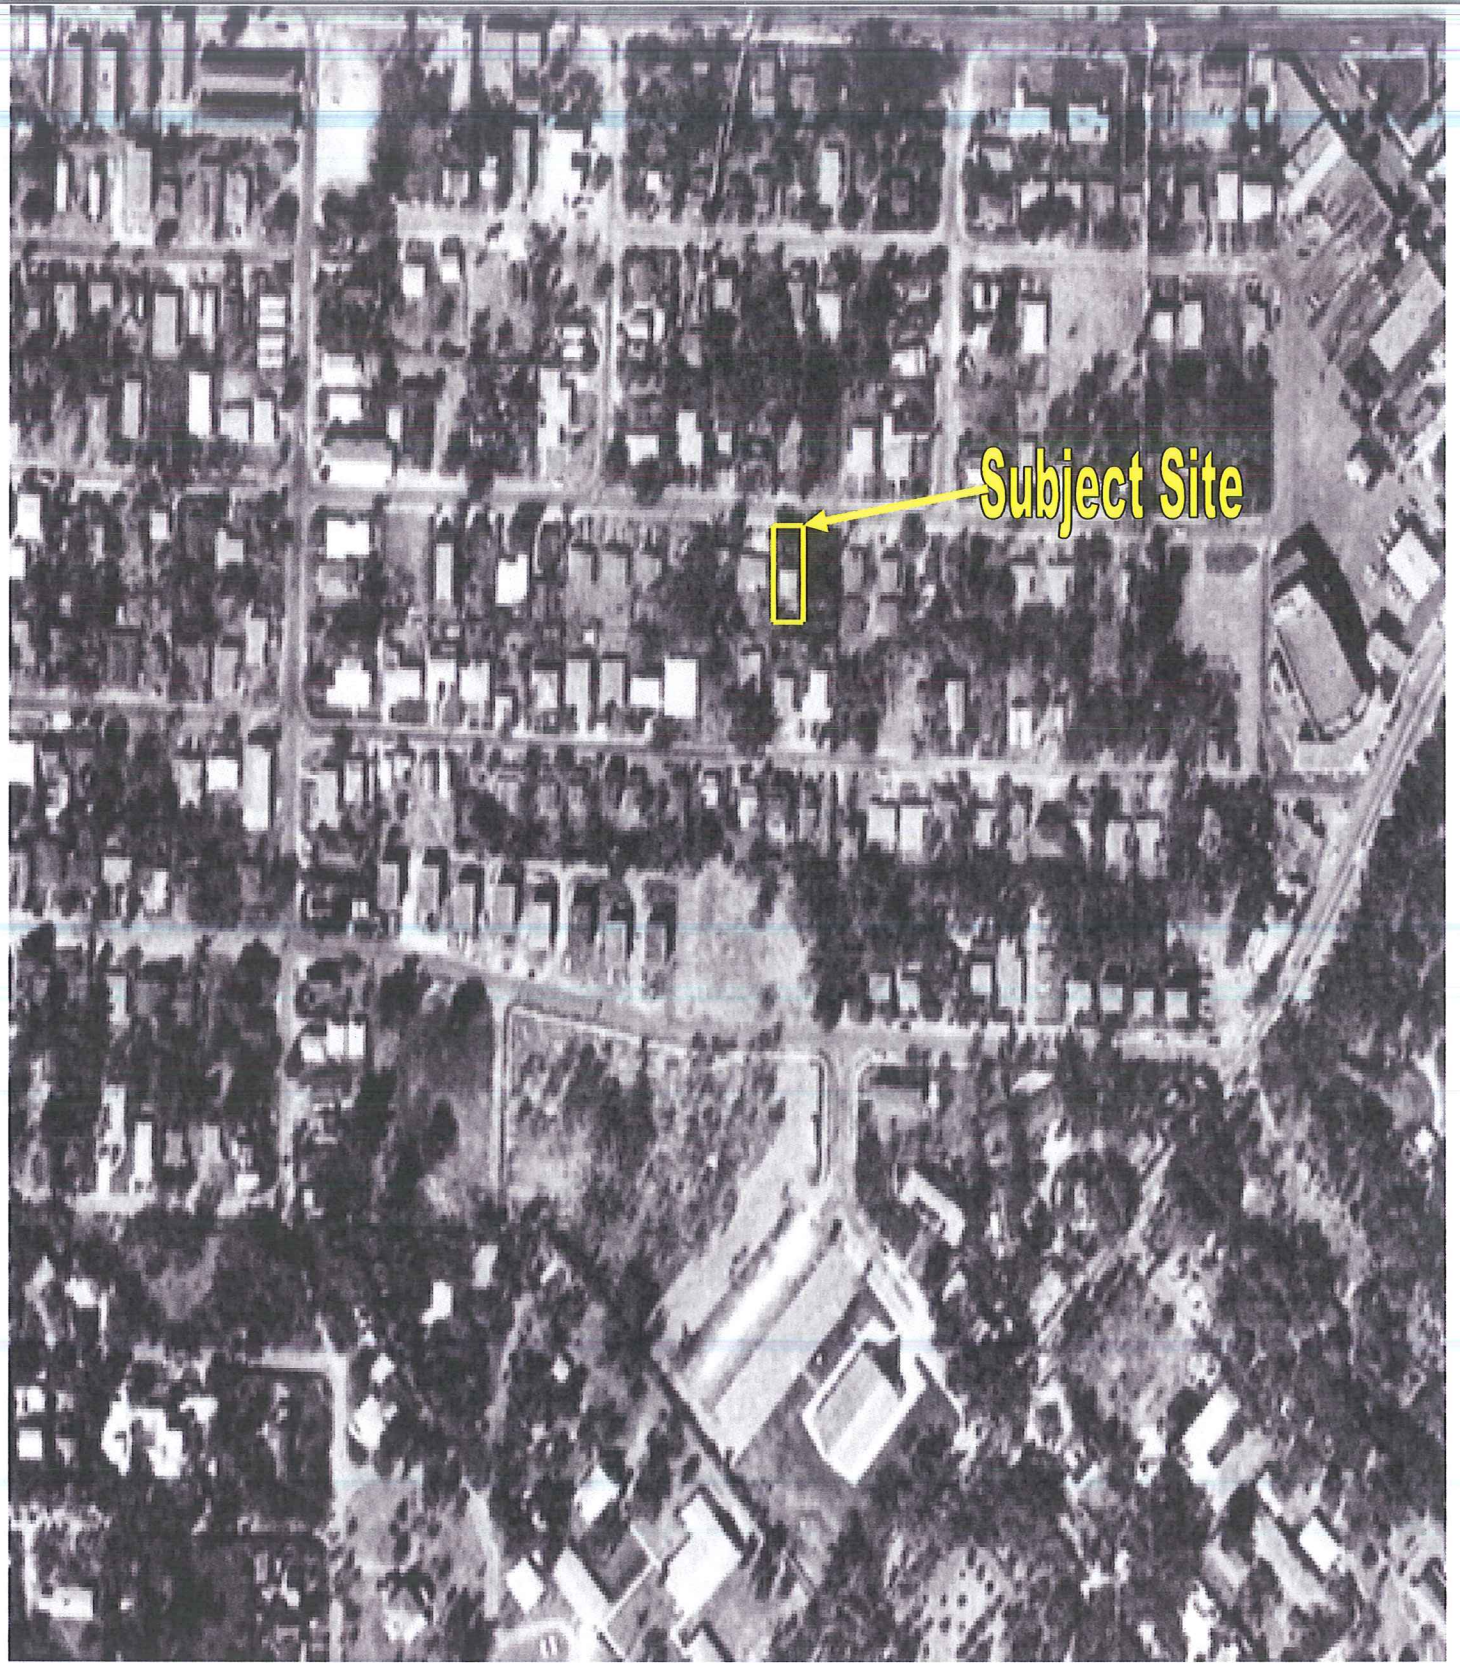
**AERIAL PHOTOGRAPH
1978
PROJECT NO.:
13 ESA 179**

Period	Comments
1963	Small structure appears at the subject site. East neighboring property appears vacant. No major changes at the north, south, and west neighboring properties. To the north of the subject site is William Avenue.
1978	Subject site and all surrounding parcels appear visibly similar to the previous aerial photographs.
1985	Small structure appears at the east neighboring property.
1997	Subject site and all surrounding parcels appear visibly similar to the previous aerial photographs.
2004	Subject site and all surrounding parcels appear visibly similar to the previous aerial photographs.
2012	Subject site appears to be cleared and vacant. No major changes at the neighboring sites.
